# PROGRESSIVE REHABILITATION

After 17 years of operation, mining activity and milling at Vedanta Zinc International's Lisheen Mine in Ireland ceased between November and December 2015. Focusing on physical closure of the mine and aftercare of the site, a best practice mine closure plan has been implemented to fully address regulatory authority permit requirements.

## TAILINGS MANAGEMENT FACILITY REHABILITATION AND RESTORATION

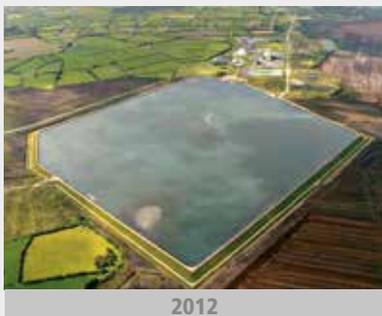
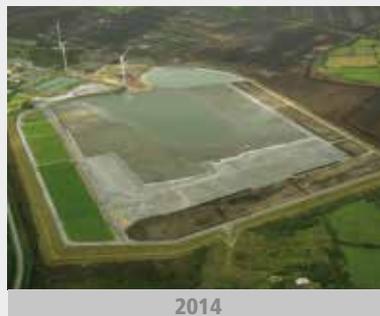
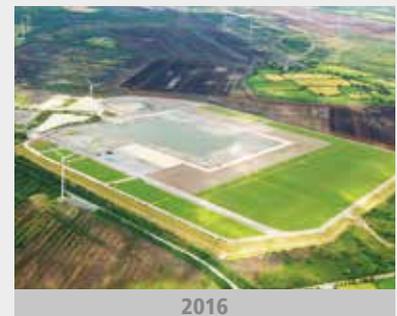
At the outset, a rehabilitation area was created by forming a tailings beach – a cap across the tailings management facility. This was followed by placement of a geotextile layer, which was covered with a rock cap. A growth medium of soil was placed across the completed rock cap.

The staged process involved:

- creation of an initial tailings beach by depositing tailings from the edge of the tailings management facility with a system of spigot pipes to locally surcharge the tailings and
- allowing the formed tailings beach to dry for up to nine weeks so that it could dewater before rock cap construction (depending on weather conditions and the time of year).

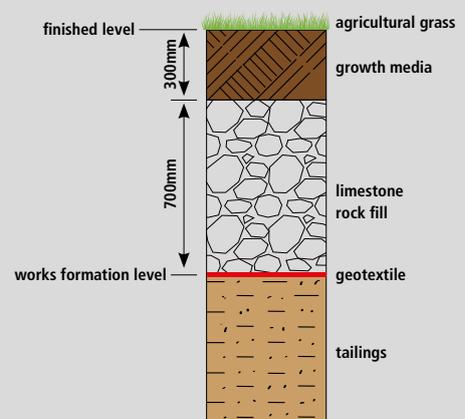
### TAILINGS MANAGEMENT FACILITY CAPPING DETAIL

The rock cap specifications include:

- Terram 1000 or equivalent non-woven geotextile (placed directly onto the tailings beach with a lap length of at least 750mm);
- a 700mm-deep layer of limestone rock with a maximum particle size of around 300mm-long axis; and
- growth medium comprising a 50:50 mix of glacial till and peat (placed across the completed rock cap to a thickness of 300-400mm).

Before the mine was established, the site was used by pastoralists for running sheep and cattle, and rehabilitation is restoring the land to allow for its previous use. The entire surface of the mine's residue dump has been covered with a geotextile material on top of which has been laid a 700mm layer of limestone, covered by a 300mm layer of soil. And an engineered wetland has been incorporated into the design to ensure that no deleterious water run-off occurs.

This soil has been planted with grass, which is already starting to provide safe and healthy grazing. The 1,000mm limestone and soil cover ensures that the surface grass does not penetrate to the underlying tailings residues. This surface is also ideal for the establishment of a photovoltaic farm as well as for the cultivation of grasses that can be used as biomass for heating or electricity generation.
